Fracture of a Polyethylene Tibial Post in Posterior Stabilized Total Knee Replacement. Two Case Reports

César Pesciallo, Fernando H. Lopreite, Germán Garabano, Fernando Tillet, Joaquín Rodríguez, Hernán del Sel
Orthopedics and Traumatology Department, Hospital Británico de Buenos Aires (Buenos Aires, Argentina)

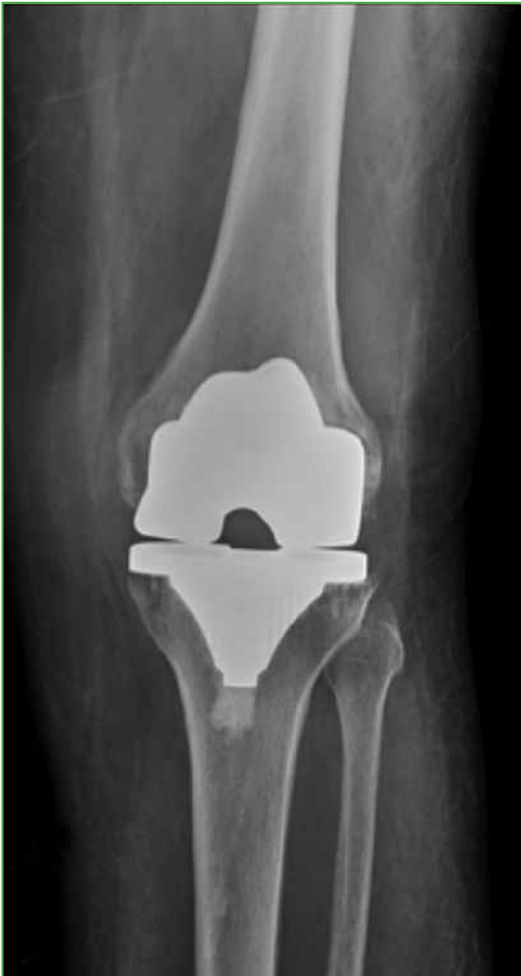
Figure 1. Frontal radiograph, 11 years after TKA. Correct alignment and placement of the prosthetic components, no signs of wear or loosening.

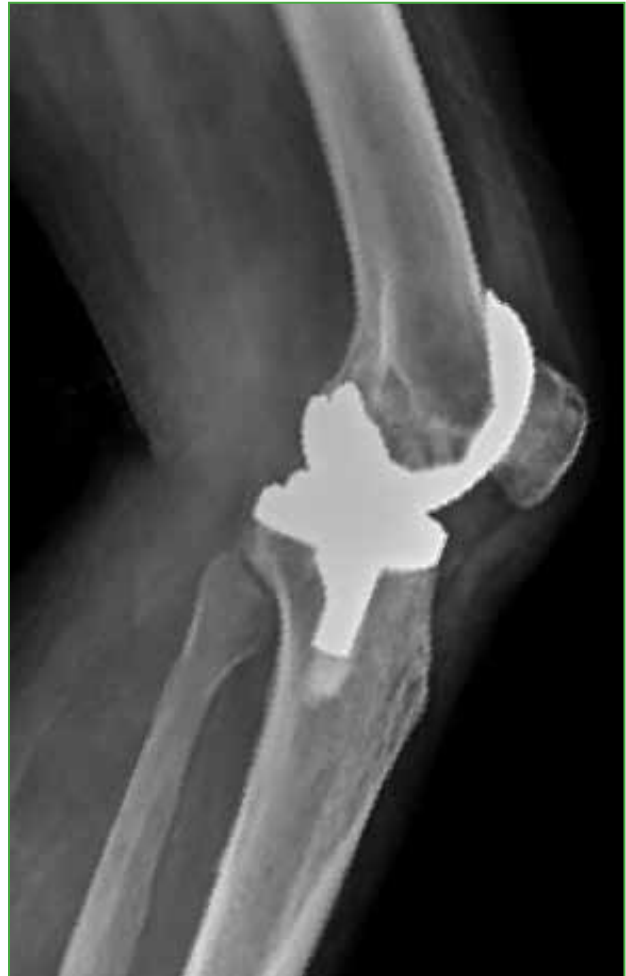
Figure 2. Profile radiograph, 11 years after surgery. Correct placement of the components, no recurvatum.

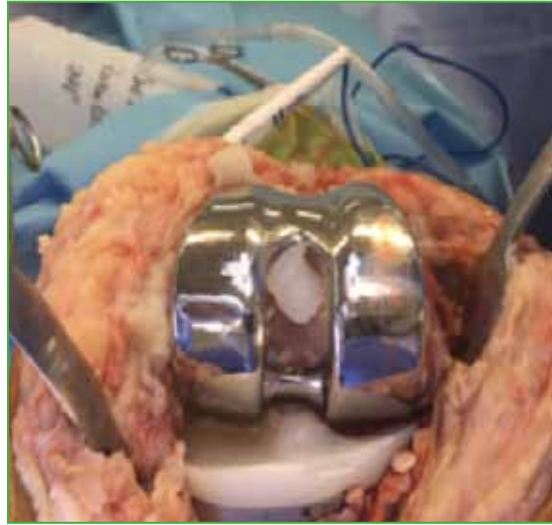
During surgery, a fracture of the central post of the polyethylene insert (liner) was detected ([Figure 5](#)). The primary prosthesis was removed and a rotating-hinge prosthesis (Endo-Model NR®, Waldemar Link GmbH & Co. KG, Hamburg, Germany) was inserted, with a satisfactory evolution to date (15 months post-operative) ([Figures 6 and 7](#)).

Figure 5. Intraoperative image. Fracture of the tibial post is observed.

In these cases, the polyethylene post fracture was generated by the anterior impact of the post with the femoral component, producing excessive wear on the base of its anterior aspect.^{7,8}

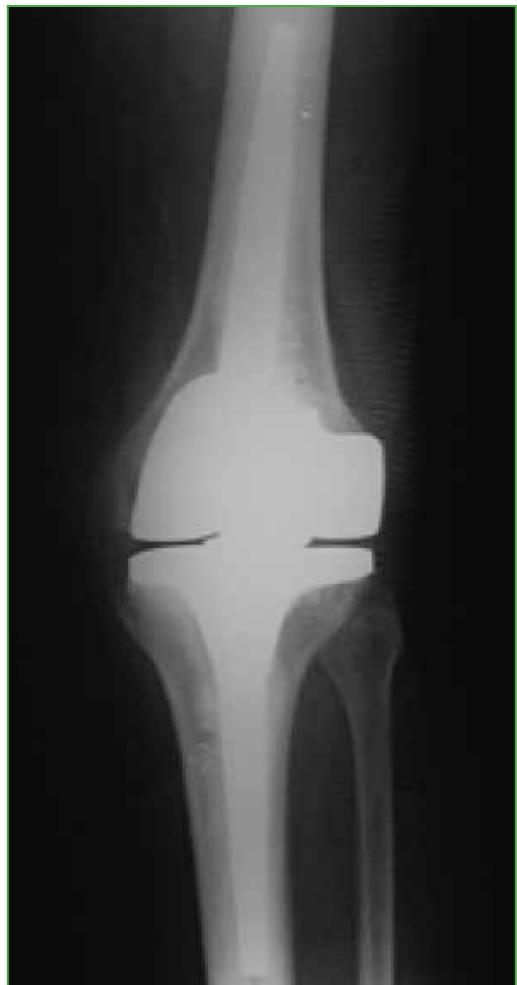
Figure 7. Profile radiograph of the revision. Adequate alignment.

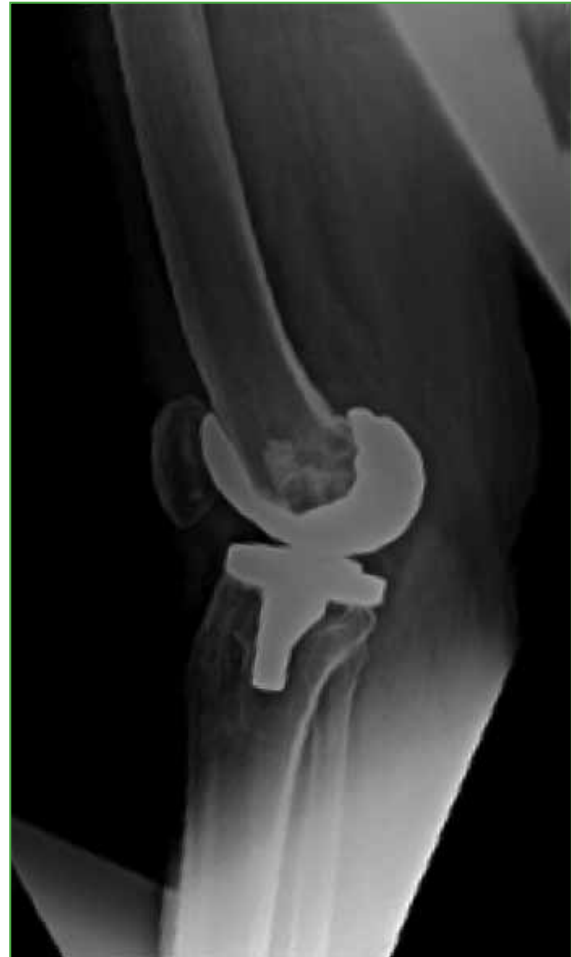
In March 2016 (approximately 2 years post-surgery) she presented to our center with recurvatum instability of the prosthesis which made walking impossible. The patient did not report trauma (Figures 8 and 9).

Figure 9. Profile radiograph . Correct placement of the components, with recurvatum.

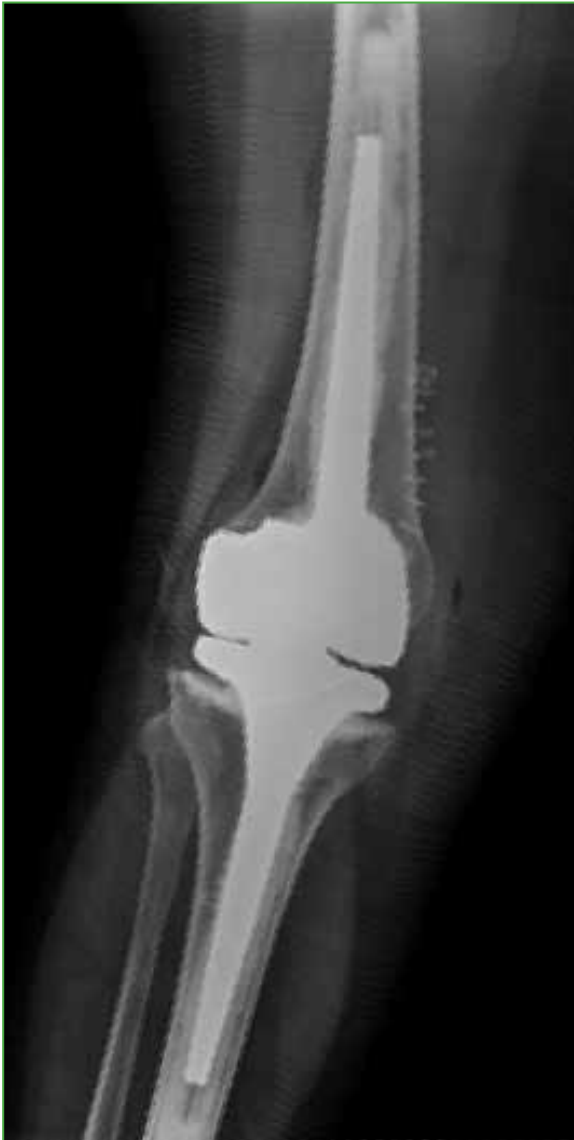
Figure 10. Frontal radiograph. Follow-up of the revision with a rotating hinge prosthesis.

In April 2016, revision surgery was carried out and an Endo-Model® rotating-hinge prosthesis was inserted. The patient has had a satisfactory evolution to date (34 months post-surgery) (Figures 10 and 11).

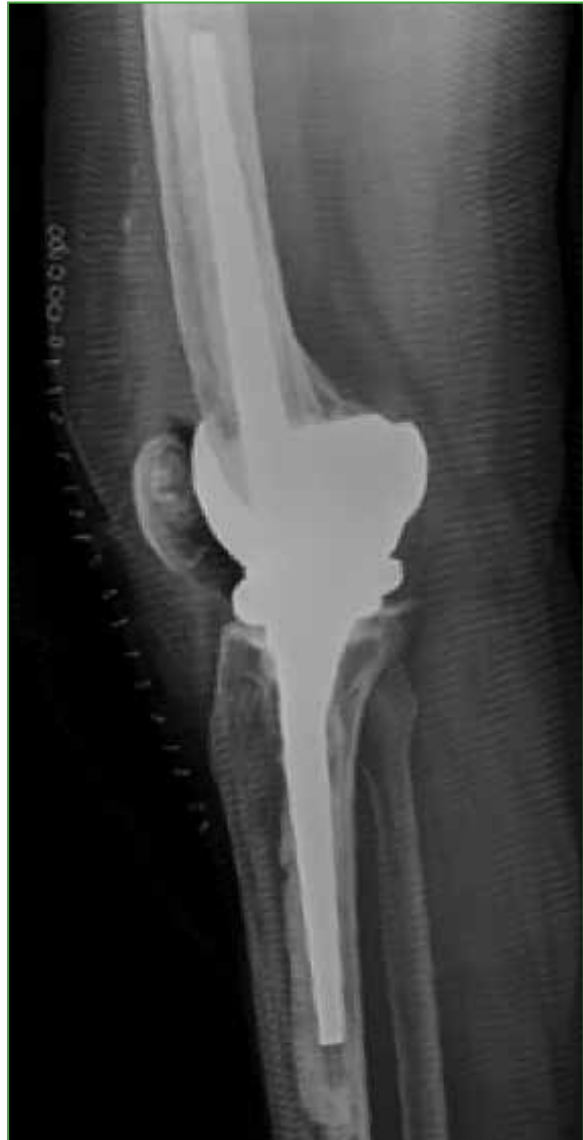
Figure 11. Profile radiograph of the revision. Adequate alignment.
